**Report on the  
Implementation of  
International Humanitarian Law  
with regards to  
the Protection of Cultural Heritage  
in the Occupied Tskhinvali Region, Georgia**

# **Report on the Implementation of International Humanitarian Law with regards to the Protection of Cultural Heritage in the Occupied Tskhinvali Region, Georgia**

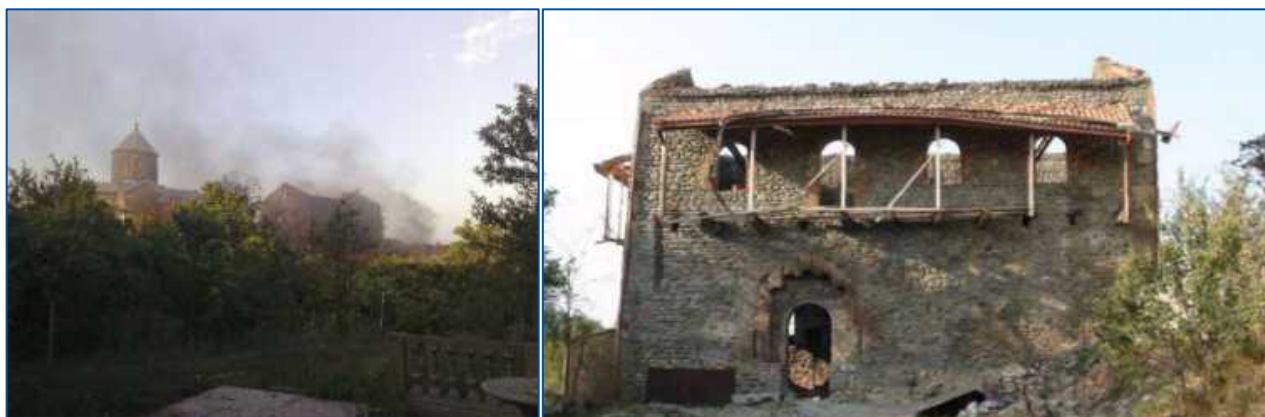
Whilst this section has only concentrated on the occupied territories, the damage to cultural heritage during the hostilities in August 2008 extended to further territories of Gori and Kaspi Municipalities - the so-called “buffer zone” - which was occupied by the Russian troops until October 2008. The damage to cultural sites concerned dwelling houses, religious sites and museums. One such case is the **Monastery Complex of Nikozi** in Gori Municipality. During the hostilities in 2008, the Episcopal Palace of Nikozi (10th century) was significantly damaged (figures 4.5. and 4.6). The palace is one of the buildings of the Monastic Complex of Nikozi, which also includes the Church of the Deity (5th - 14-15thC), the Archangel Church, Bell Towers, and monastic residences (2000s). The rectangular Episcopal palace is two-storied and was built using stone and brick, and the structural details were made of brick. The restoration of the palace had started before 2008; however, during the events of the war, up to 30 shells fell on the territory of the Nikozi complex. These destroyed monastic residences, and the fire caused by the falling shells burned the interior of the Episcopal Palace and caused the roof to collapse. During 2009-2014, the Bishop's Palace of Nikozi was completely restored.

Figure 4.5 (left): Nikozi Archangel Church during the 2008 shell strikes © Mitropolit Isaiah (Chanturia)

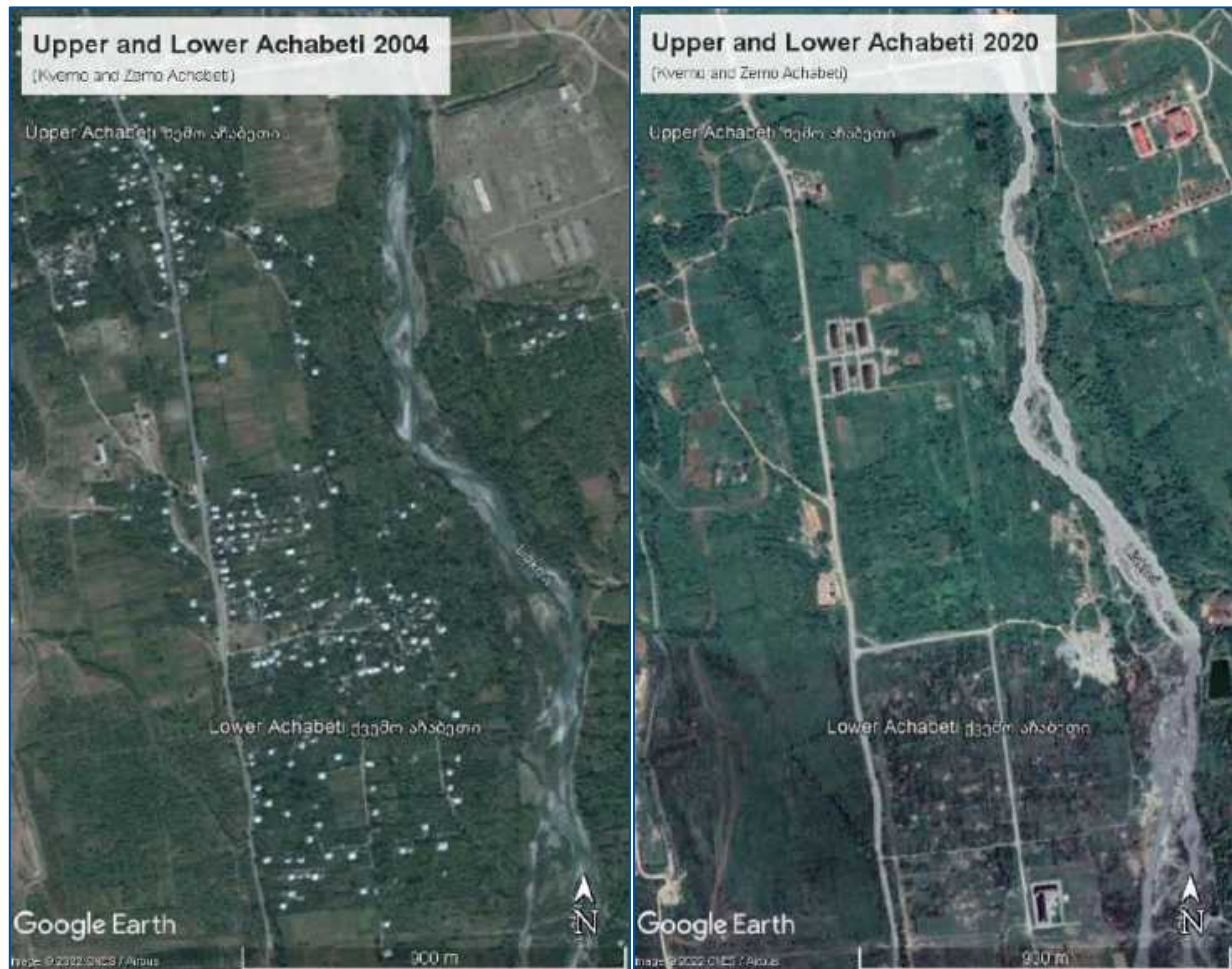
One such example has been completed in the village of Achabeti<sup>45</sup> (figures 4.7a,b).

Figure 4.7a (left): Upper and Lower Achabeti, 30 September 2004 (Maxar satellite image via Google Earth)  
Figure 4.7b (right): New constructions in Upper and Lower Achabeti following the clearance of the villages,  
06 June 2020 (CNES / Airbus satellite image via Google Earth)

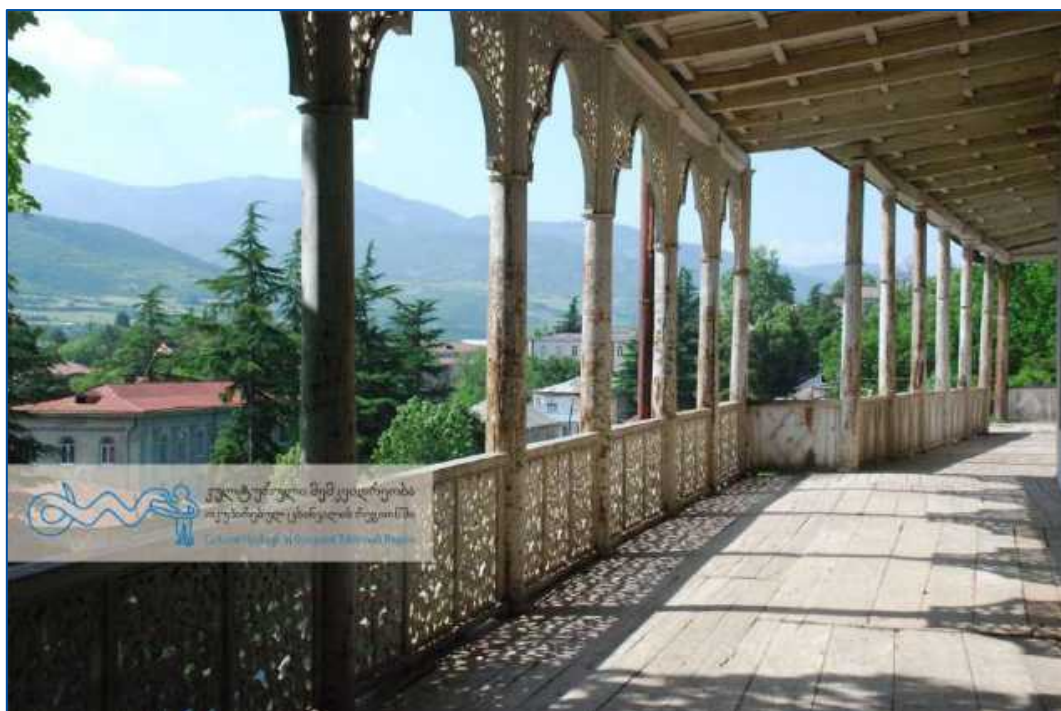
The building is largely in good condition, with the exception of the bath building, which is in a poor condition. Besides unauthorised repairs to the roof, which have been taking place since 2008, eyewitnesses reported that the dome of the bath house collapsed around 2017. A news report (Byazrova 2017) indicated that the Department for the Protection of Cultural Heritage Monuments of the de facto Ministry of Culture of South Ossetia intended to restore Bibiluri-Eristavi's house-museum (Palace of Ksani Valley Eristavs is referred to like this by the Ossetian media) in Akhagori district as part of their 2017-18 program of works, which eyewitnesses confirm took place.

Figure A1.4: The Palace of the Eristavs in 2009 © Didi Liakhvi Valley Museum-Reserve

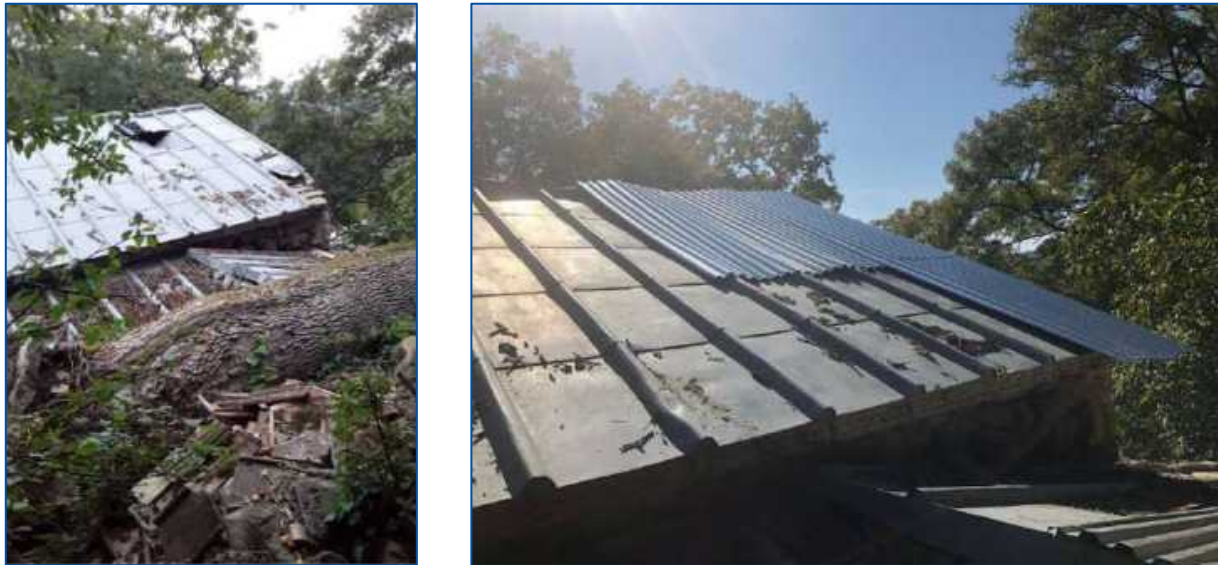
A1.7a,b). This can also be seen in the photos found online (Ravknatashvili 2020d). Georgian nuns managed to repair the roof with remote support from the Georgian National Agency for the Preservation of Cultural Heritage as the access to the region has been blocked since 2019

Figure A1.7a,b: The roof of Armazi church in 2020 © Didi Liakhvi Valley Museum-Reserve

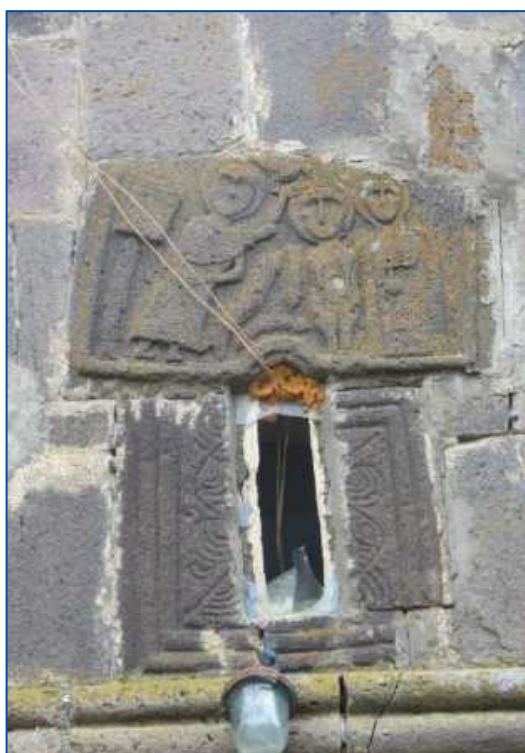
However, the site is marked as damaged during hostilities in 2008 as according to eyewitness reports, its windows shattered as a result of the military operations (figure A1.8).

Figure A1.8: Avnevi Church of the Assumption, shattered window (2013) © Didi Liakhvi Valley Museum-Reserve

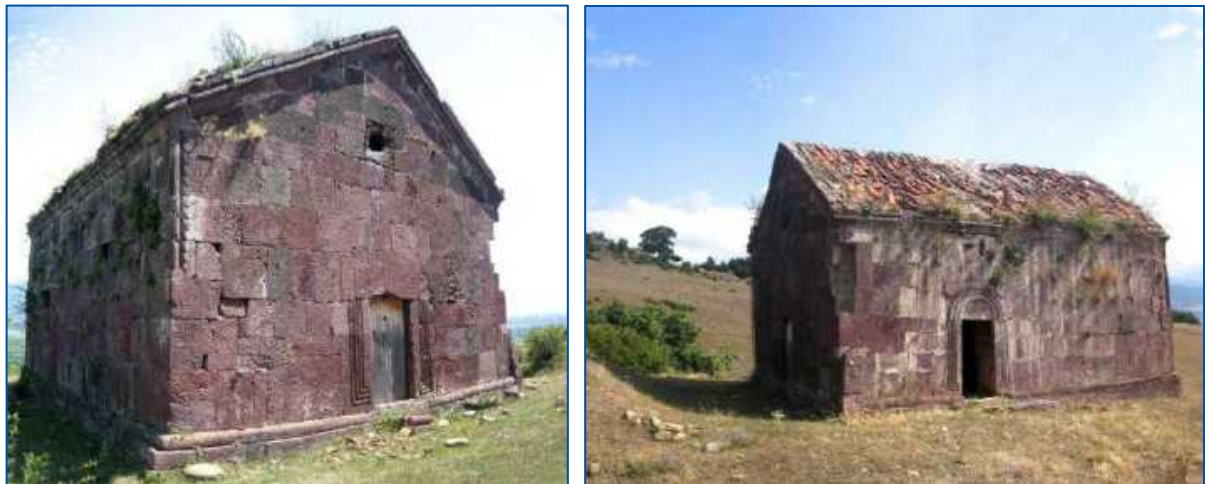
The Church dates to the 14th Century. Although the majority of the historic village is now almost completely ruined, the Church of St Elijah appears intact, visible on sequential Google Earth imagery from Maxar on 19 October 2009, as of imagery until the last image on CNES dated 16 July 2019.

Figure A1.10a,b: Church of St. Elijah, Berula © Paata Basishvili

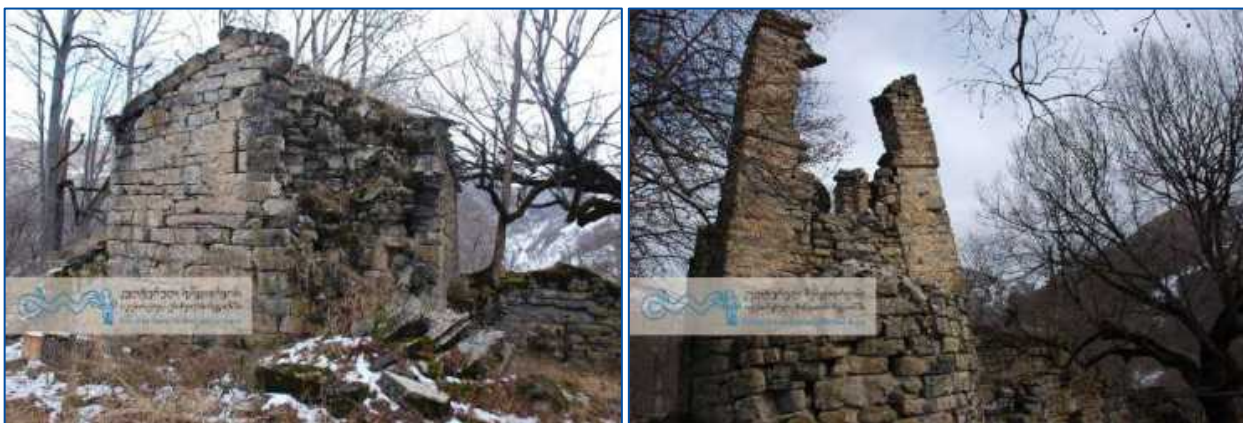
The 14<sup>th</sup> century wall paintings of St. George Church complex in Akhagori wall paintings are gradually deteriorating, according to eyewitness reports. This problem was noted in the original database, which records: “The church once had frescoes; The painting, which was supposed to have been created in the fourteenth century, is now almost entirely obsolete. Surviving from the frescoes are the Saviour depicted in the conch of the altar, surrounded by flying angels in the baptismal Sharavand - Mandorla, and on the west wall a composition of the Annunciation and the Holy Warriors - St. George and St. Demetrius. Another composition depicting a feast - the ascent to hell can be seen on the north door. Currently the corner of the north-west wall of the church is open, which damages the still surviving painting on the west wall.” The site was, and remains, in a Poor condition (figure A1.11a,b, figure A.1.12).

Figure A1.11a,b: Exterior of St. George Complex in 2009 © Blue Shield Georgia

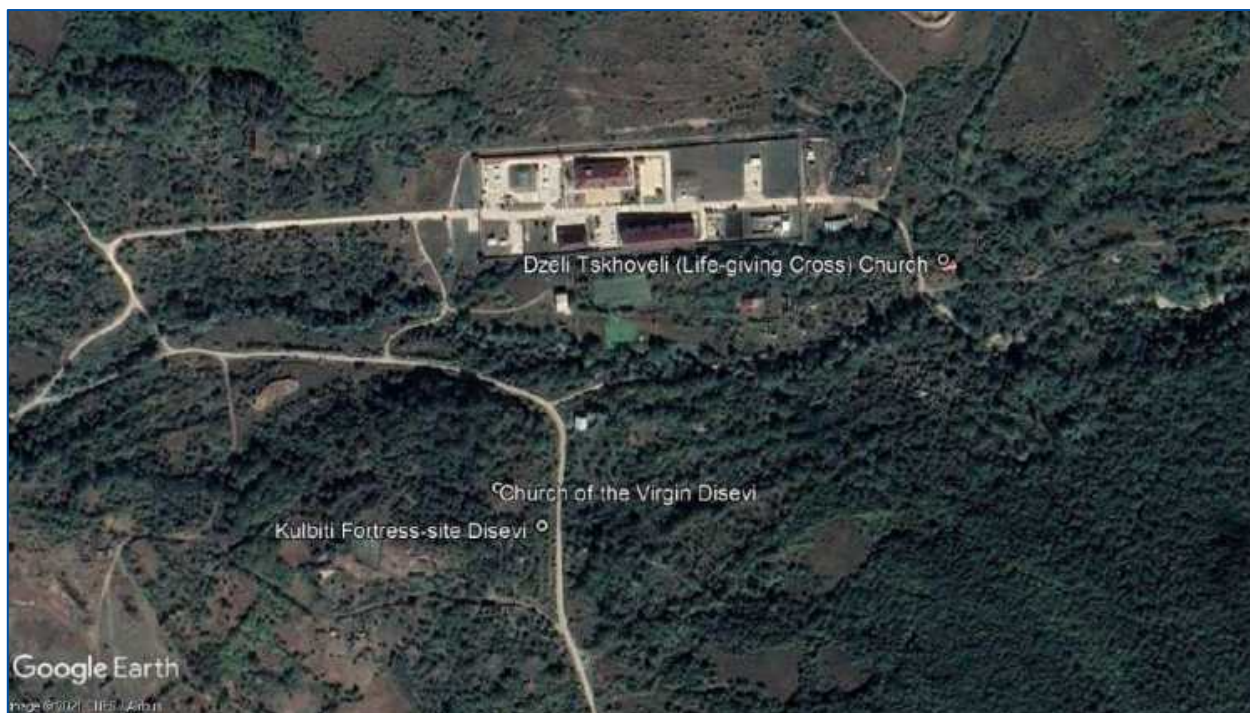
Figure A1.15: The churches of Disevi on satellite imagery, next to a military facility. CNES /Airbus satellite image dated 10 September 2021 via Google Earth.

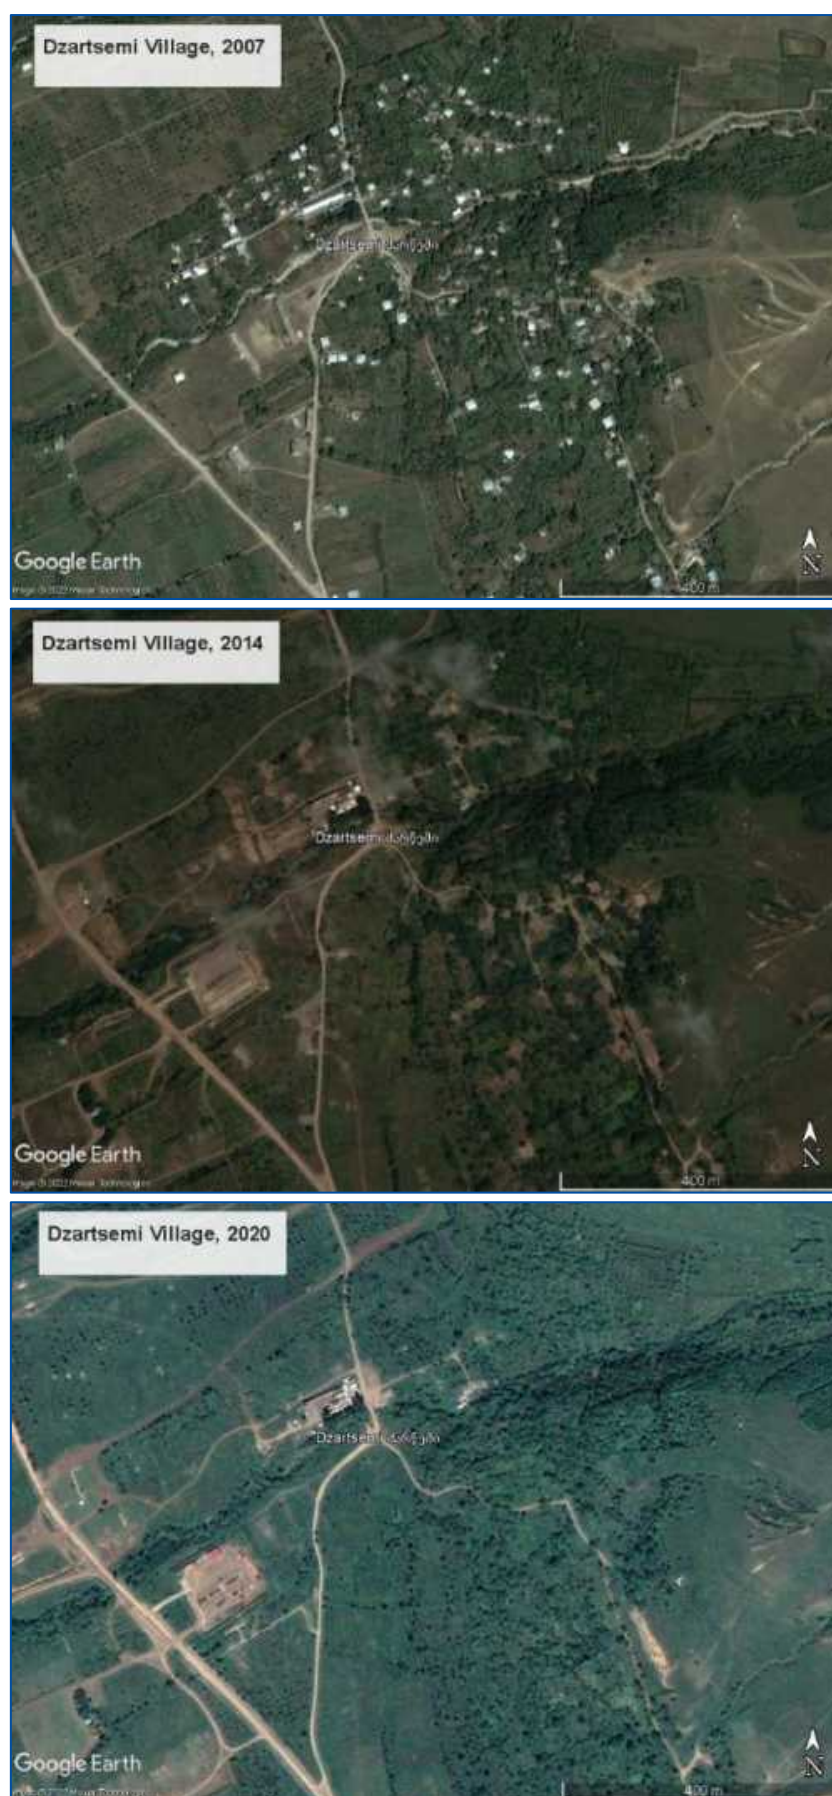
Figure A1.20, A1.21, A1.22: The situation of Dzartsemi village - 26 July 2007 (Maxar satellite image), 11 July 2014 (Maxar satellite image), and 6 June 2020 (CNES/Airbus satellite image), all via Google Earth.

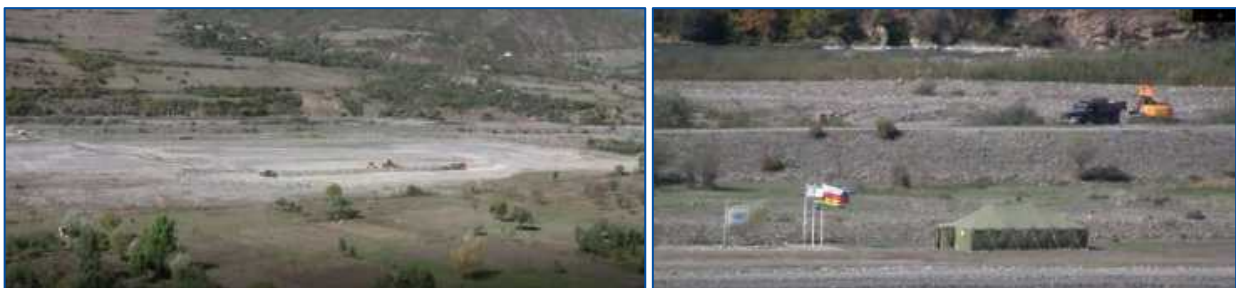
Figure A1.32, A1.33: Historic Orchards of the palace being bulldozed (2010) © Didi Liakhvi Valley Museum-Reserve

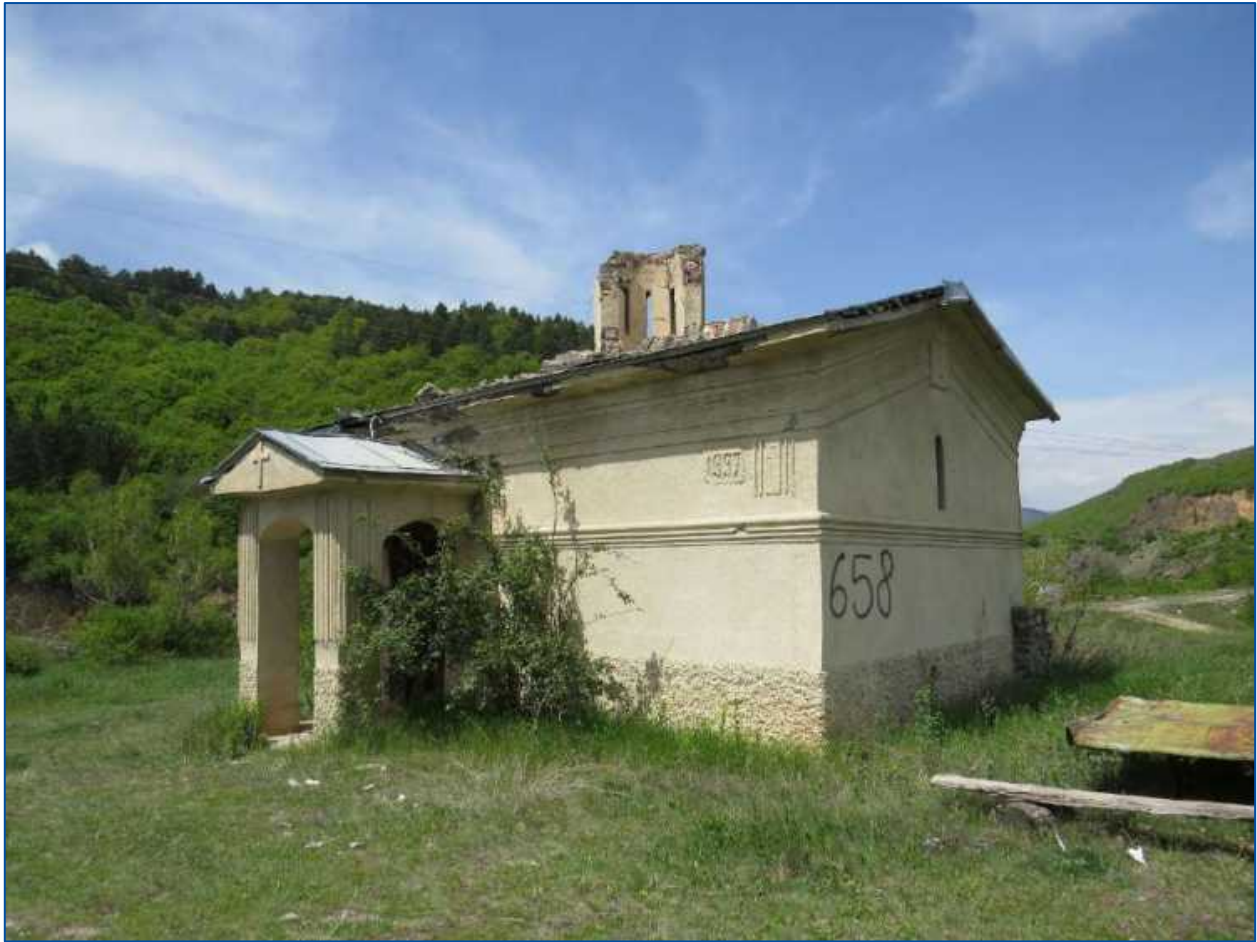
Figure A1.43: Kashueti Church 2013. The building is labeled with the number 658: it was expected that the church would be demolished, but it was rebuilt. © Didi Liakhvi Valley Museum-Reserve

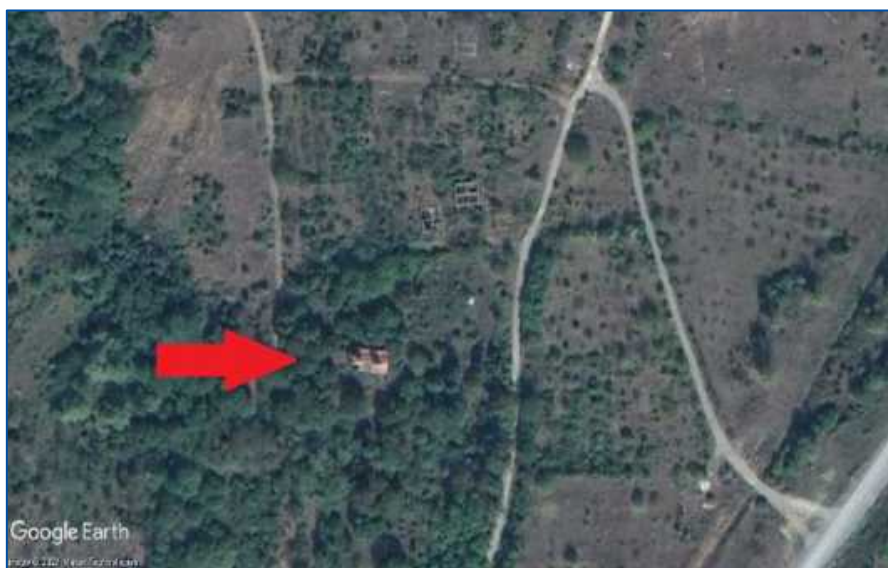
Figure A1.48: Archangel church is still standing (CNES imagery 2020), while the rest of the village has been torn down.

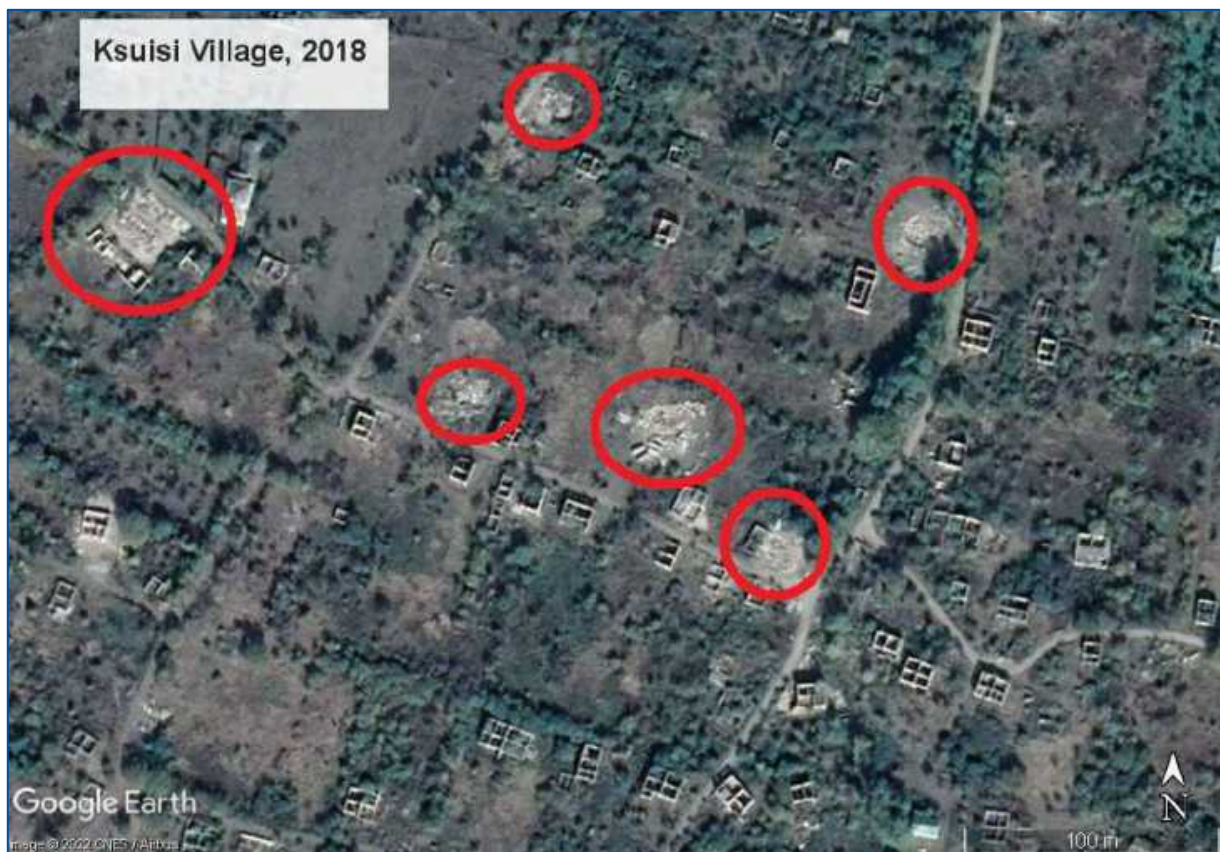
Figure A1.49: Destroyed houses at Ksuisi village, 11 October 2018 (CNES/Airbus satellite image via Google Earth).

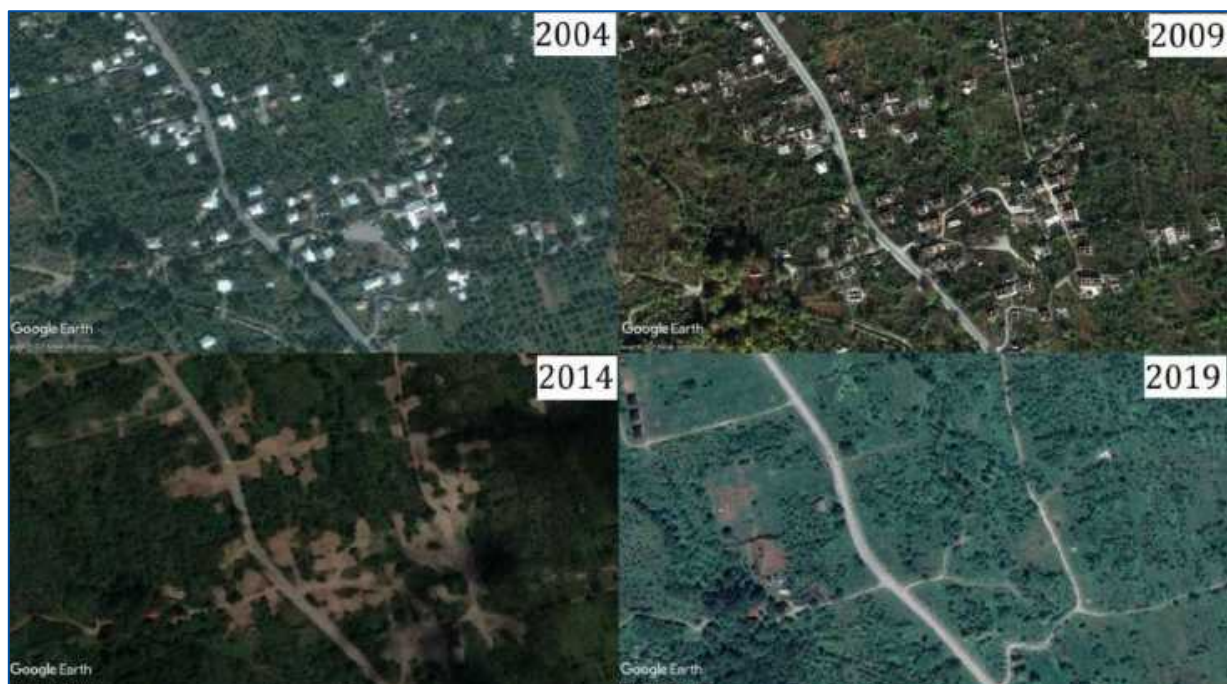
Figure A1.50a,b,c,d: Kurta Village pre war and post war. Top left: standing village 30 September 2004 (Maxar satellite image via Google Earth) Top right: Initial destruction 19 October 2009 (Maxar satellite image via Google Earth) Bottom left: Demolition 11 July 2014 (Maxar satellite image via Google Earth) Bottom right: Total destruction 21 October 2019 (CNES/Airbus satellite image via Google Earth).

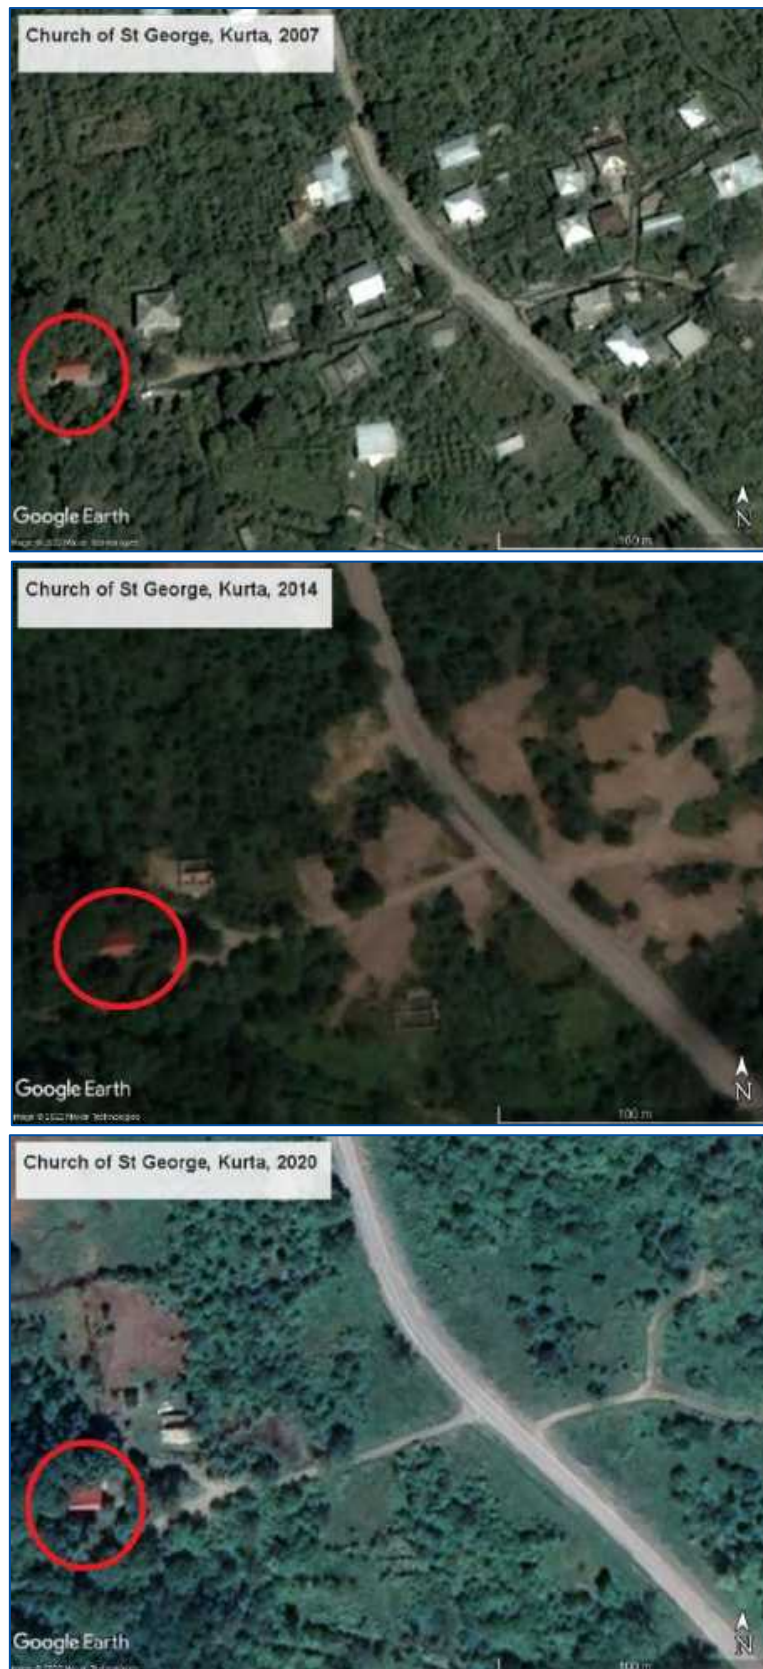
In spite of the village's destruction, St. George's church is still standing. Figure A1.51 (top): St George's Church before village demolition 26 July 2007 (Maxar satellite image via Google Earth). Figure A1.52 (Middle): St George's Church during village demolition 11 July 2014 (Maxar satellite image via Google Earth). Figure A1.53 (Bottom): St George's Church, Kurta, after village demolition 11 July 2014 (Maxar satellite image via Google Earth).

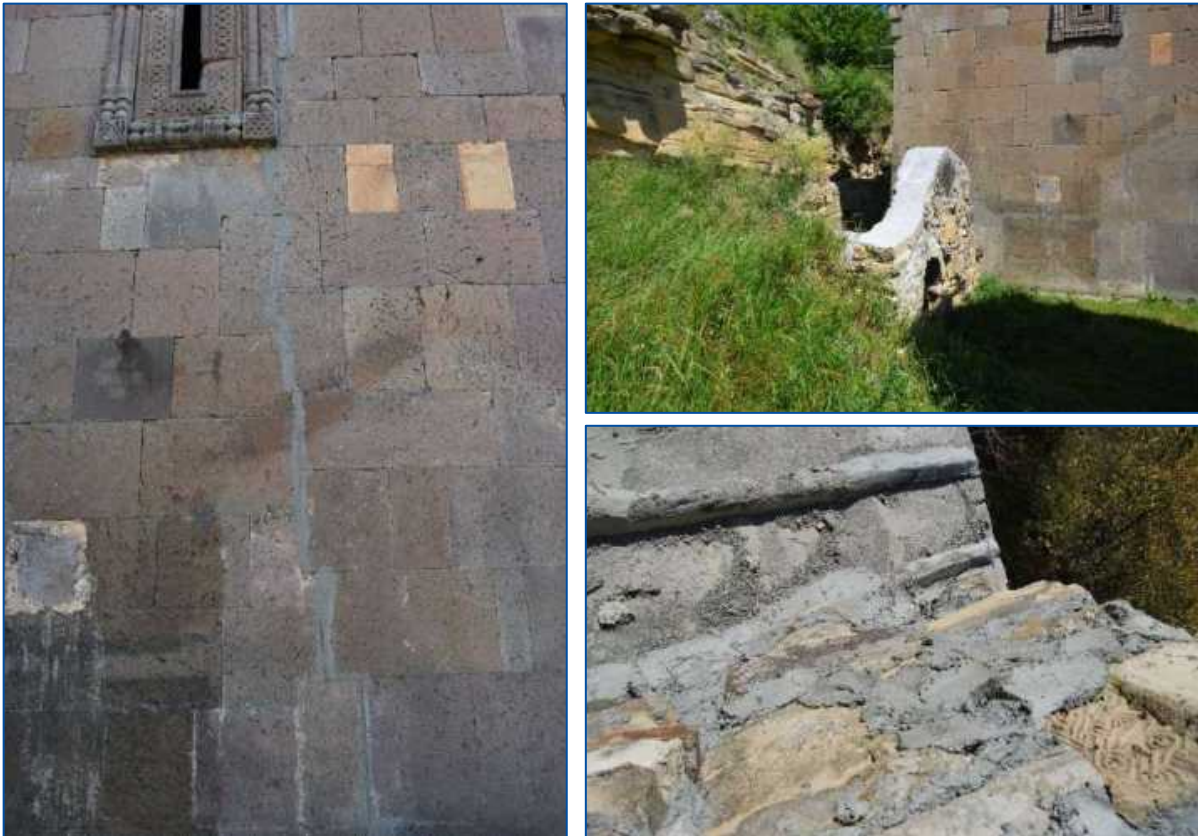
Figures A1.56a,b,c: Use of cement in the reconstruction and repair work at Tiri Monastery, 2016. ©Blue Shield Georgia.

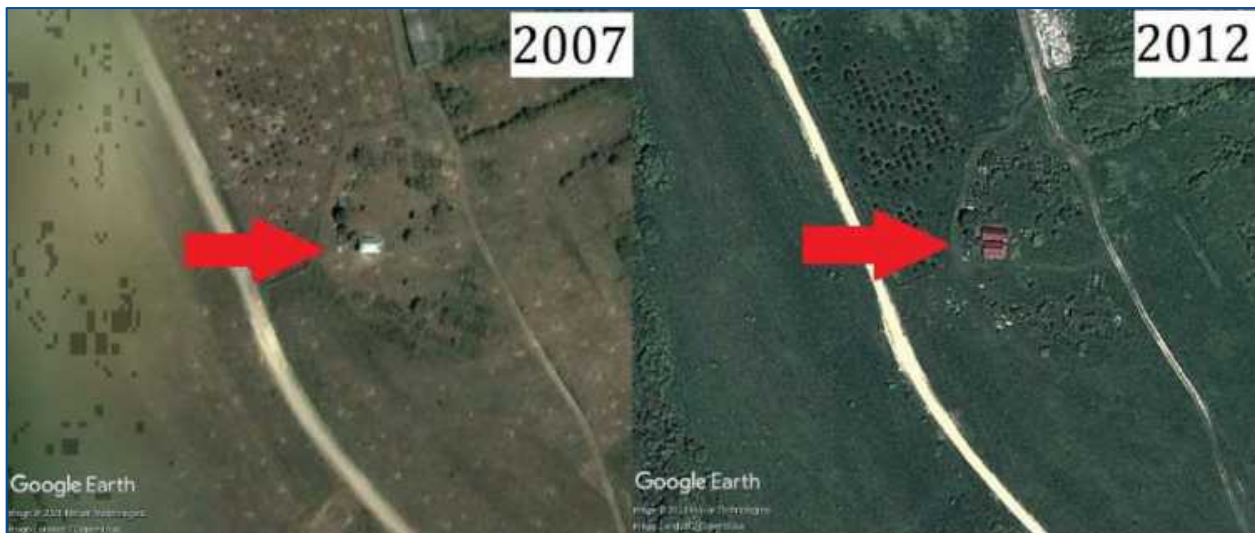
Figure A1.60 a,b (left): Skhliti village church, 26 July 2007. (Right) the new building next to it, 17 May 2012. Maxar satellite images via Google Earth.

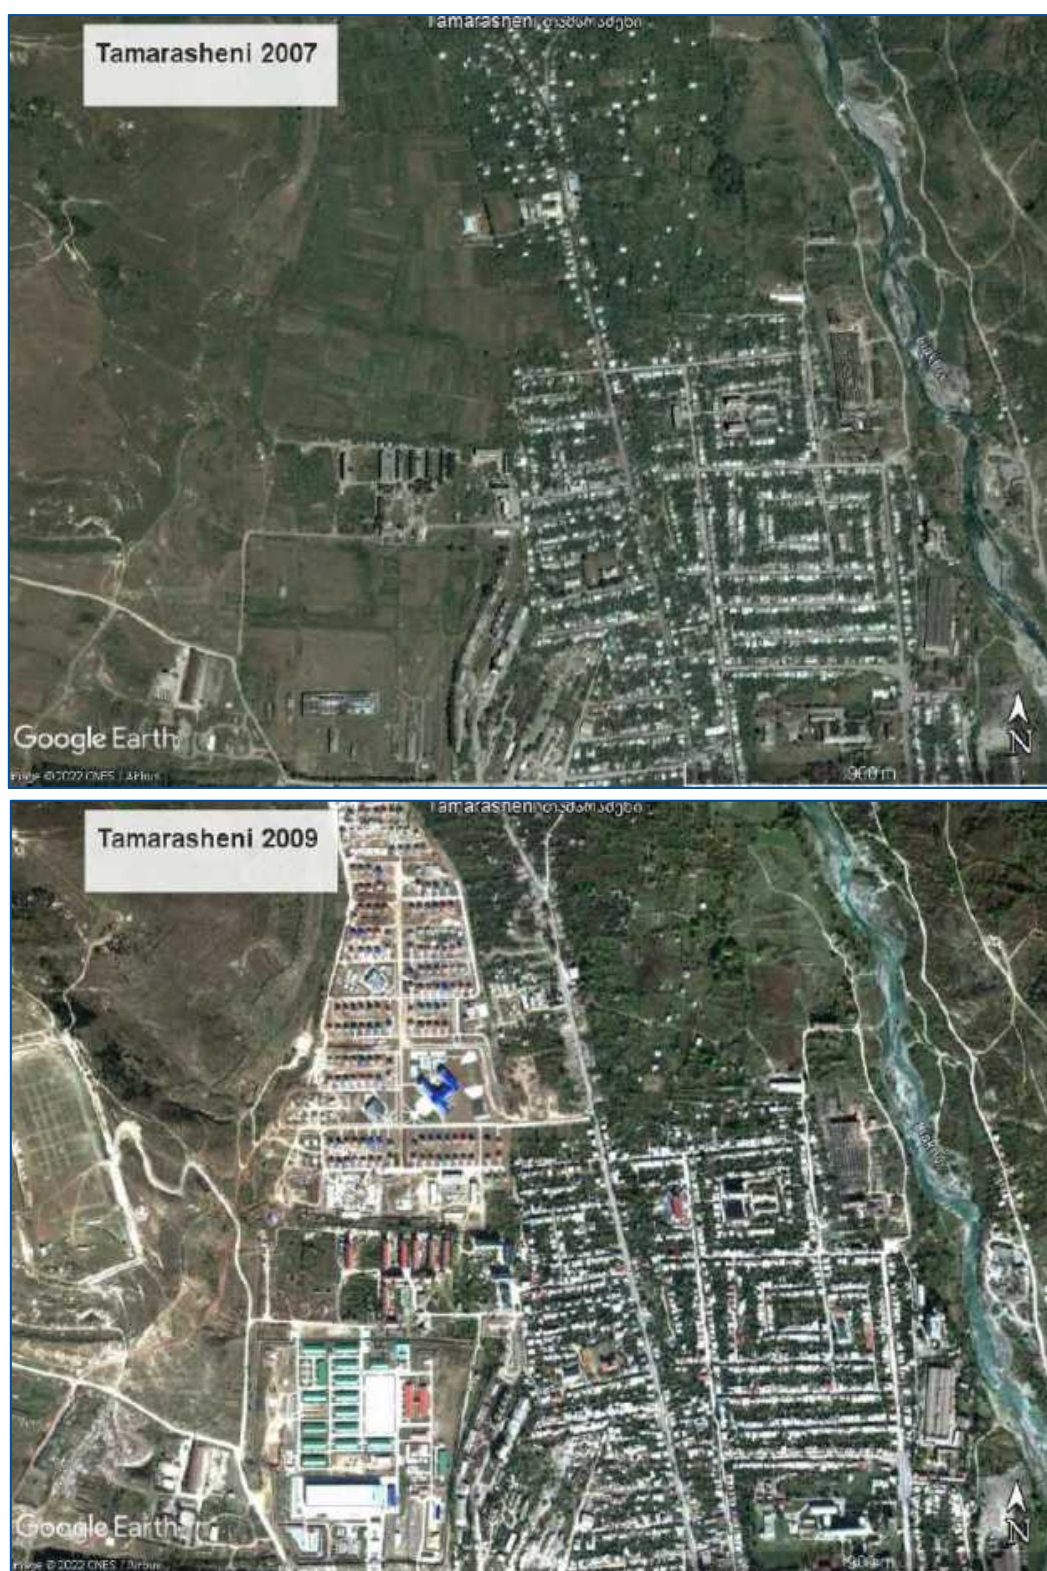
Figure A1.61, A1.62: The transformation of Tamarasheni within two years. The northern construction is “Moskovski” . Top: Pre war, 26 July 2007. Bottom: Post war, 19 October 2019 (Maxar satellite images via Google Earth).

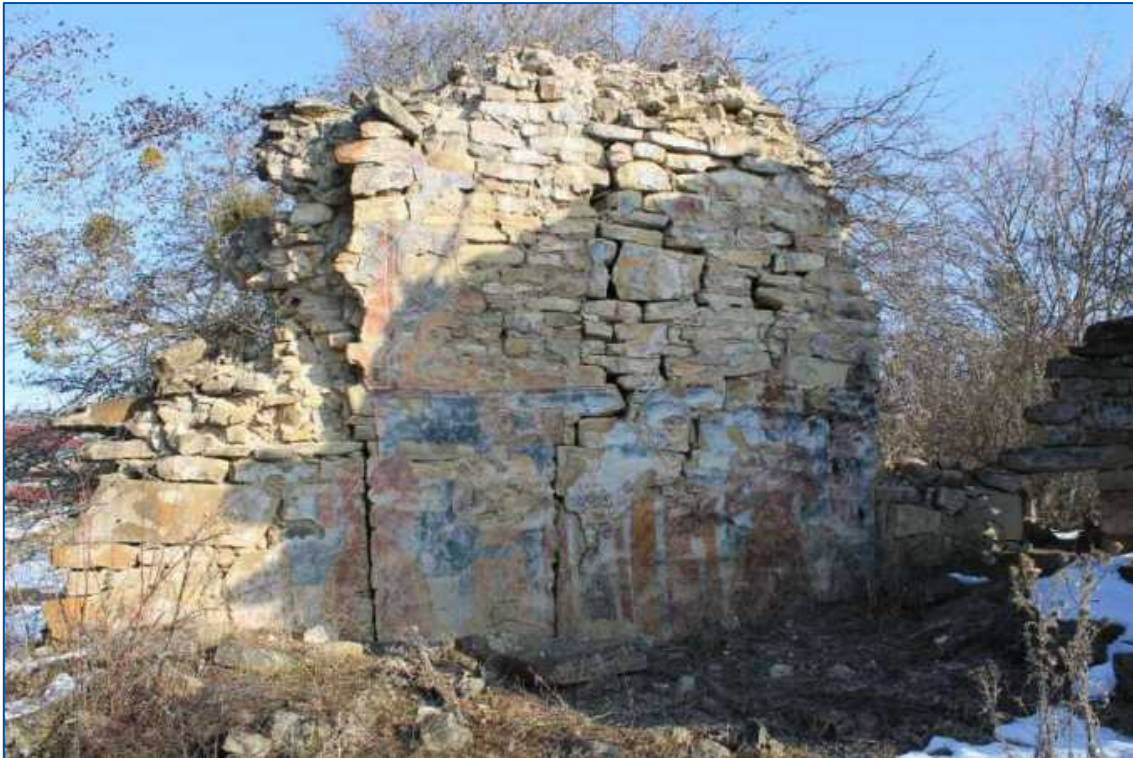
Figure A1.77: Vakhtana Church of the Virgin, the Northern wall (2014) © Didi Liakhvi Valley Museum-Reserve
